SHARPE'S POND DAM

(NDI I.D. PA-0888

PHASE I INSPECTION REPORT.

NATIONAL DAM INSPECTION PROGRAM

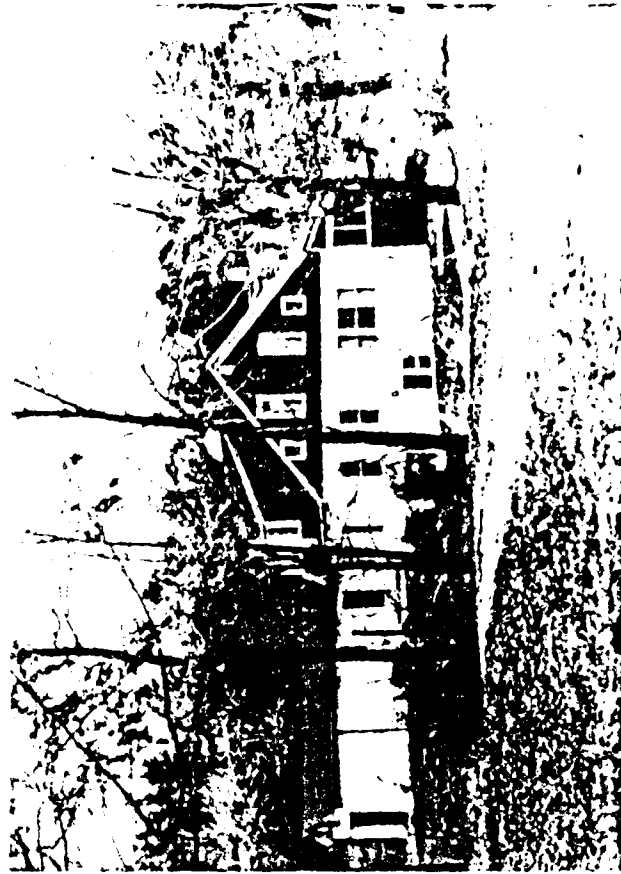
PHOTOGRAPH NO 8

stream flows under two road embankments then discharges into Negro Pond (DER I.D. 066-010) about 1,000 feet further downstream. In this reach, two homes are located within the potential floodplain in the event of a dam failure. In particular, a home 500 feet from the dam is built very close to the streambed and is likely to receive significant damage. It is estimated that failure of the dam could cause loss of more than a few lives at the two downstream houses.

| <u>PHOTOGRAPH NO.</u> | <u>DESCRIPTION</u> |
|---|---|
| 8 | House (mile 0.2). |

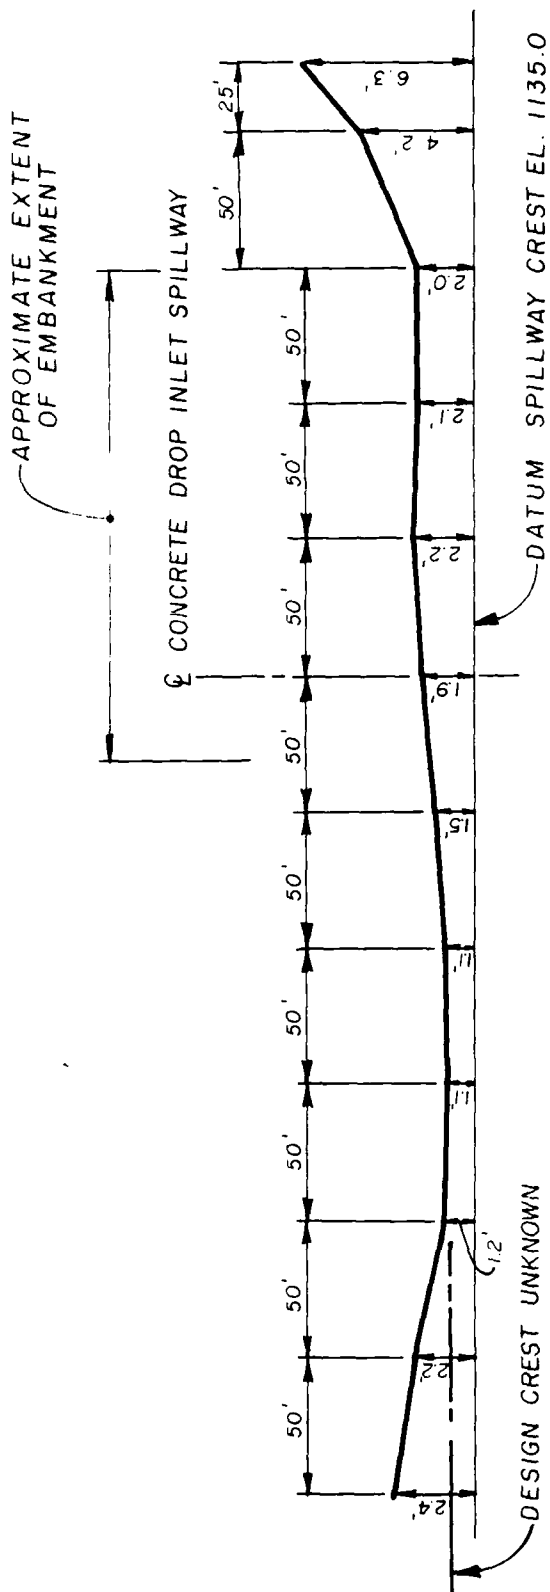
DAM CREST PROFILE (LOOKING DOWNSTREAM)

The crest of the dam was surveyed relative to the drop inlet spillway crest elevation and it was found that the crest of the dam, from the spillway to the right abutment, is generally about two feet above the drop inlet crest level. From the spillway to the left abutment, the crest of the dam slopes down to a low area on natural ground about 100 to 200 feet from the drop inlet structure. This area can serve as an emergency spillway for release of excess flow. The crest of the embankment is illustrated in Plate 3.

d. Overtopping Potential. Various percentages of the PMF inflow hydrograph were routed through the reservoir and it was found that the spillway can pass approximately 10 percent of the PMF without overtopping the low spot on the embankment. For 50 percent of the PMF, the low spot on the embankment would be overtopped for a duration of approximately 12.8 hours with a maximum depth of about 1.5 feet.
